**CONTRACT NO. 68-W9-0007
WORK ASSIGNMENT NO. R05043**

**INTERIM FINAL
PRELIMINARY REVIEW/VISUAL SITE INSPECTION (PR/VSI) REPORT
FOR
RCRA FACILITY ASSESSMENT (RFA)**

**MILLCO CONSTRUCTION COMPANY
WORTHINGTON, OHIO
OHD986971422**

AUGUST 1993

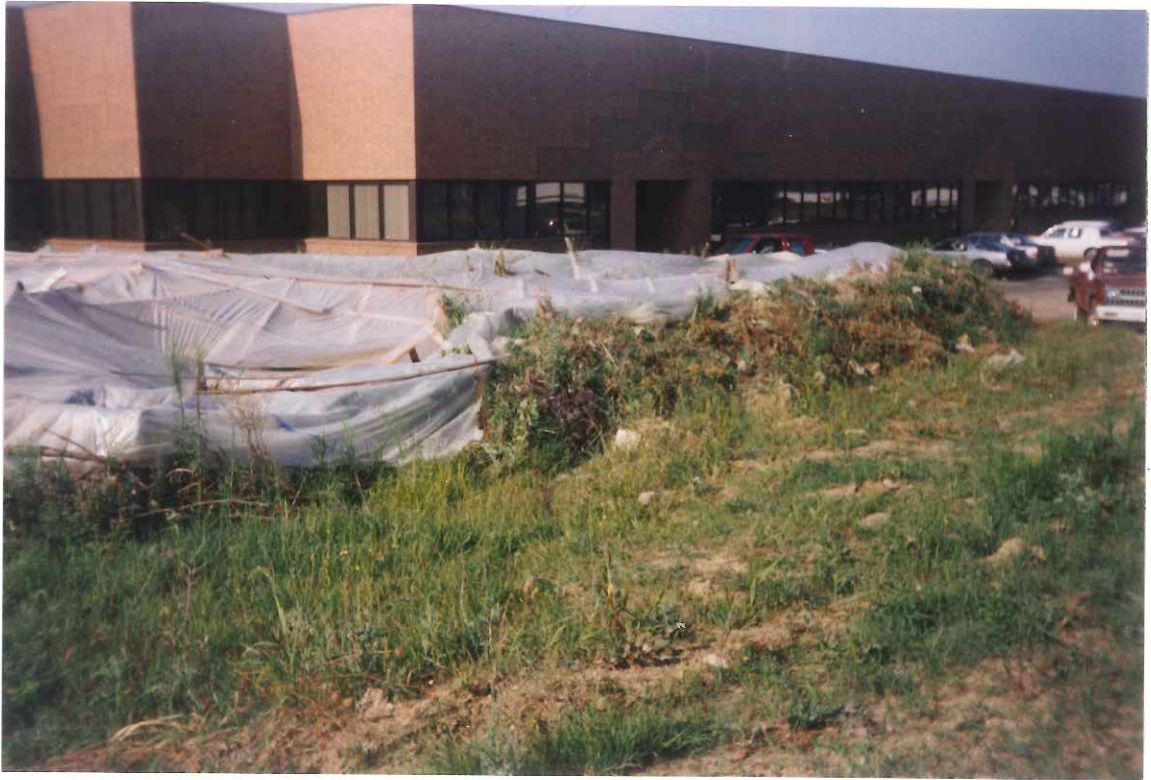
- D. Release Controls: The circular berm contains a mixture of aggregate and the surrounding soil. There are cracks in the berm which contain water and the plastic covering the circular berm is torn which has resulted in additional water accumulation.

PHOTOGRAPH 1: Circular berm of aggregate and soil remaining from previous waste pile.
Date: August 16, 1990

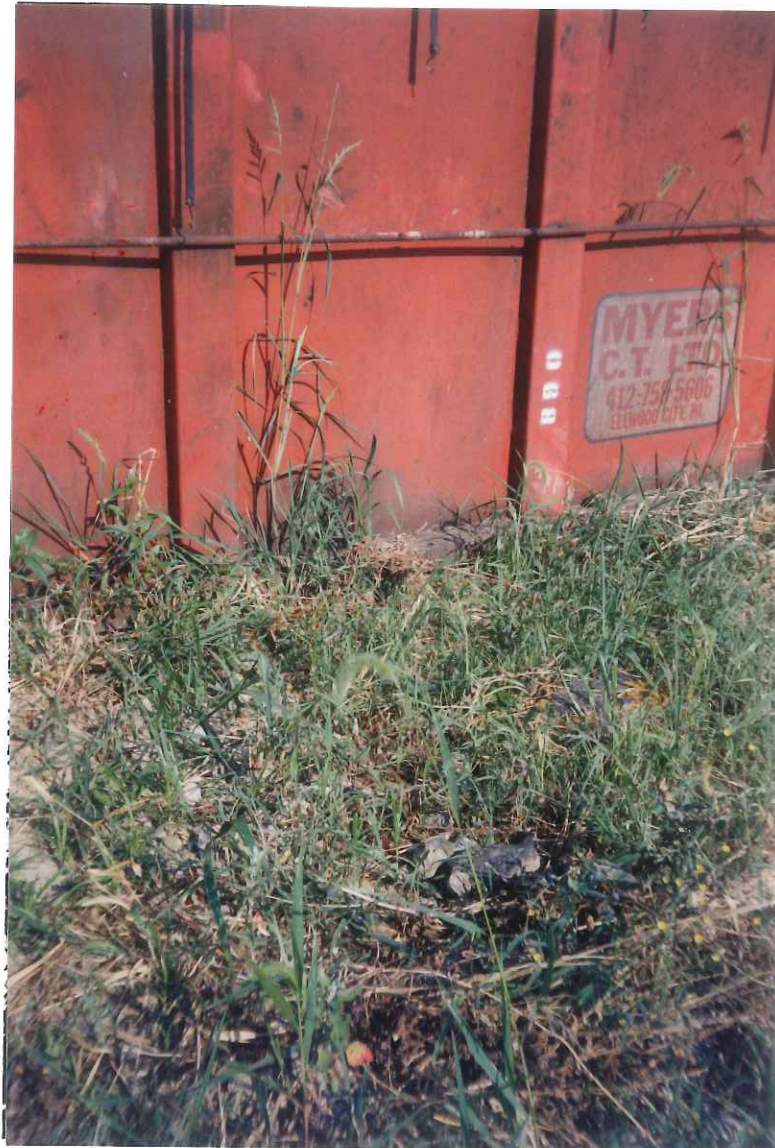
The soil is already contaminated with chromium and lead. Aggregate can still be found on the ground in and around the circular berm and under the roll-offs. The level of the water table and the presence of an existing aquifer are unknown. Because this information is unknown, there is potential for release of contaminants to the ground water. The aggregate material was first stored in six separate piles. The piles were then combined into one large pile and covered with plastic. Most of the one large pile was excavated and the material was stored in roll-off containers. When the material was excavated, a circular berm was built around the excavated depression to capture runoff. The bermed area still contains an uncovered percentage of the hazardous material. Therefore, due to the exposure and movement of surface water through the aggregate material over time (e.g., leaching, runoff), there is a high potential for release of contaminants into the soil.

PHOTOGRAPH 2: Residuals of aggregate that remain from incomplete removal of waste pile (base of a roll-off).
Date: August 16, 1990

The principal environmental concerns at the Millco Construction Company's waste pile site are the soil contamination and potential ground water and surface water contamination associated with the aggregate waste pile. Listed below are the recommended sampling points, parameters for analysis and other actions necessary to complete the unit investigation.

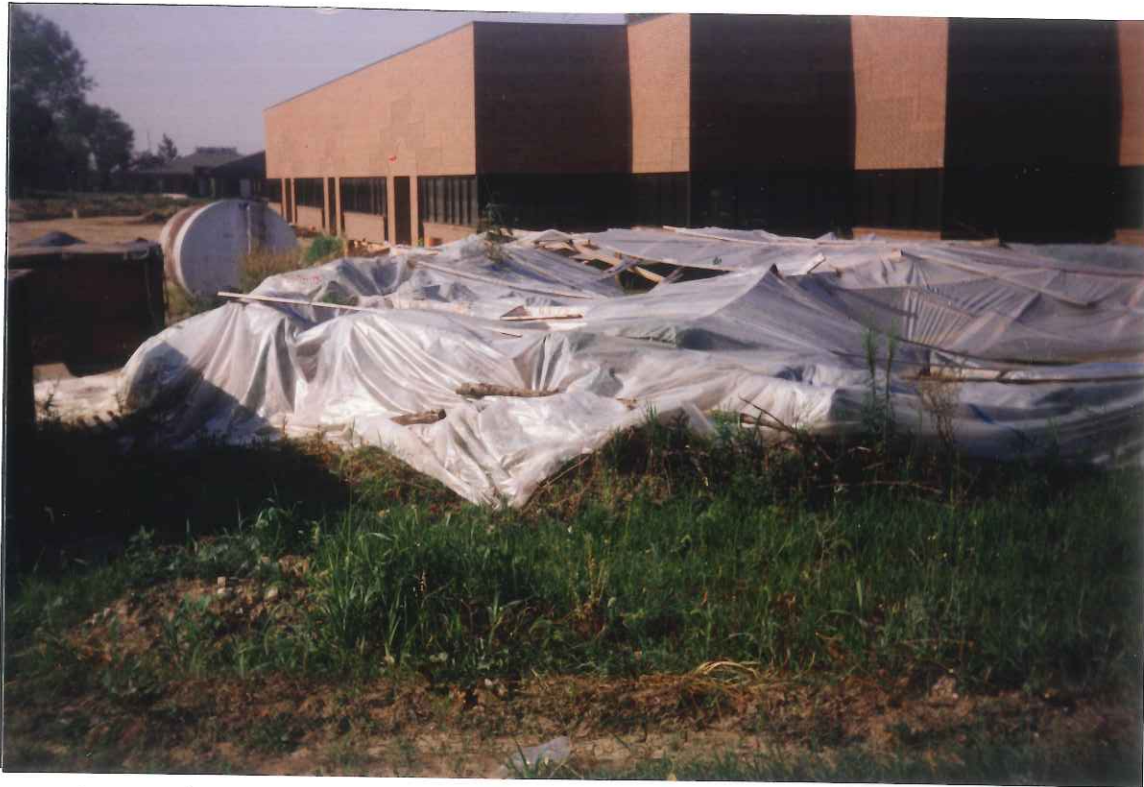
- E. Release History: The aggregate material has been exposed since its placement on-site.
- F. VSI Observations: Aggregate was scattered across the surface of the soils in the waste pile area located on the south and southwestern portion of the site. This area is south of the building located on-site. The circular berm wall of material has cracks on the outside (Photograph 4, Appendix A). The condition of the inside wall of the berm was concealed. Water has collected inside the berm, as seen through the top of the torn plastic in Photograph 3, Appendix A.

PHOTOGRAPH 3: Torn cover of remaining circular berm of aggregate and soil that was part of the waste pile.
Date: August 16, 1990

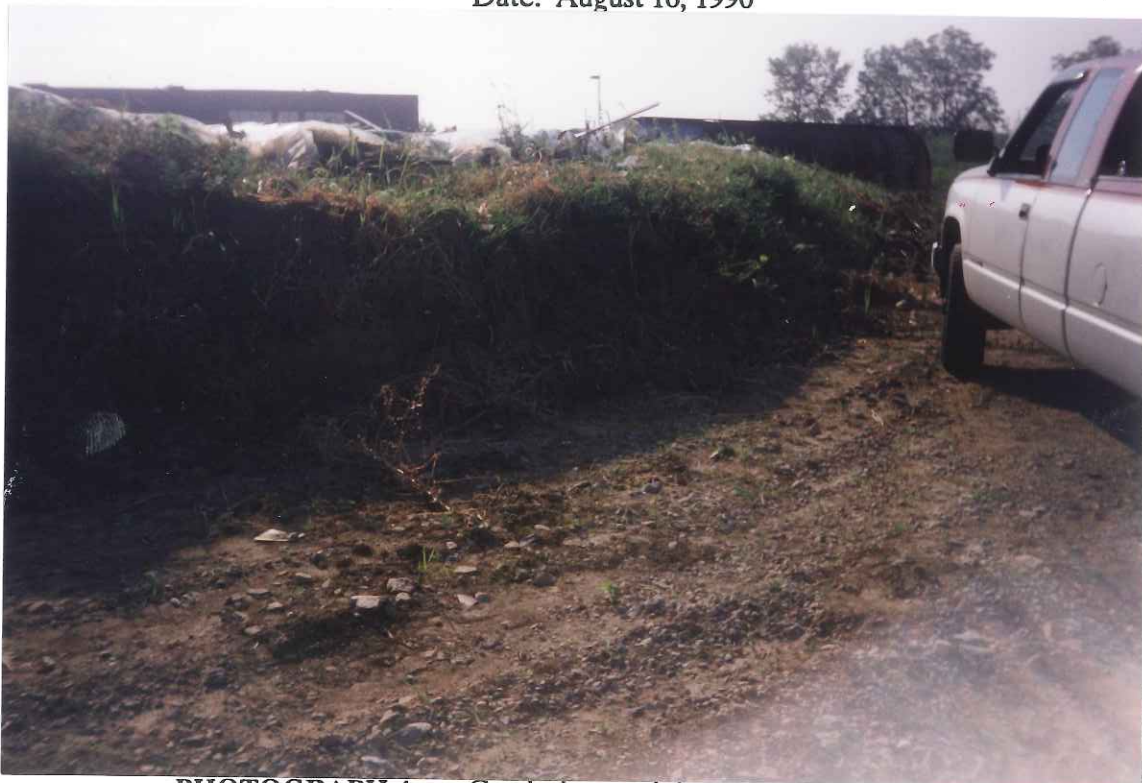
The impounded water may be contaminated from the aggregate/soil mixture due to the fact that some of the water may have been contained there for over one year. No other surface water was noted within the vicinity of the waste pile area. Storm sewers may possibly be located in the parking lot adjacent to the berm, but none were located. Although there were no bodies of water observed in the area during the VSI (except for the water that has collected in the circular berm), there is a potential for release from normal area surface runoff.

PHOTOGRAPH 4: Cracks in remaining aggregate and soil berm which contains water.
Date: August 16, 1990

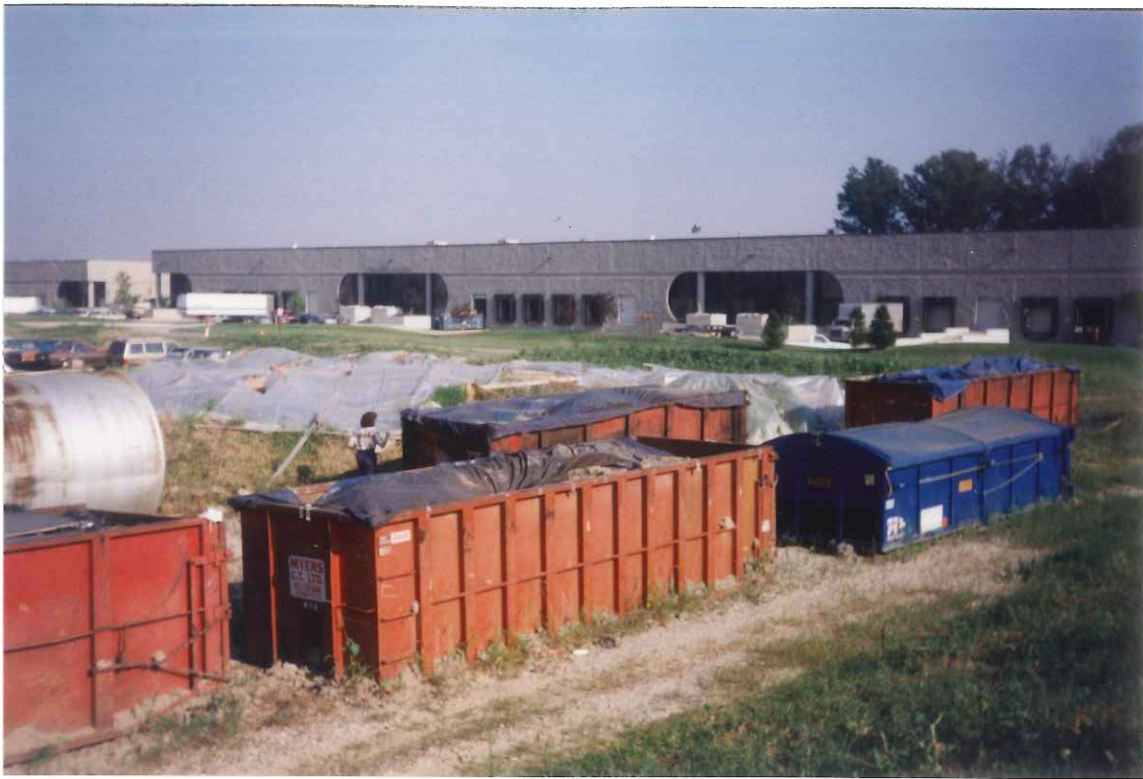
- D. **Release Controls:** Two of the roll-off boxes are completely covered with tarps and two roll-offs are only partially covered with tarps. One roll-off box is completely uncovered and has trash on top of the aggregate material. One roll-off box is particularly worn and rusty.
- E. **Release History:** Unknown. There is a potential that dust could be blown into the air from uncovered or partially exposed roll-offs. A hard rain could cause overflow of material onto the ground.
- F. **VSI Observations:** Only two of the roll-offs were completely covered with tarps. One was uncovered and filled with trash. One roll-off in particular looked very worn and rusty. Aggregate was scattered around the base and in between the roll-offs.
- G. **Sample Results:** No additional sample results were provided by facility personnel.

This unit consists of five roll-offs located within the waste pile area. Two of the roll-offs are completely covered with tarps, one roll-off is uncovered but has trash on top, and two are partially covered with tarps. One roll-off is worn and rusty.

PHOTOGRAPH 5: Roll-offs.
Date: August 16, 1990

2. Roll-Offs - Soil and ground water sampling is recommended around and beneath the roll-offs once they are removed (described in Number 1, above). At a minimum, analytical parameters should include chromium and lead and it may be further necessary to test for all compounds listed on the RCRA Appendix IX List. Concentrations of chromium and lead have been confirmed.

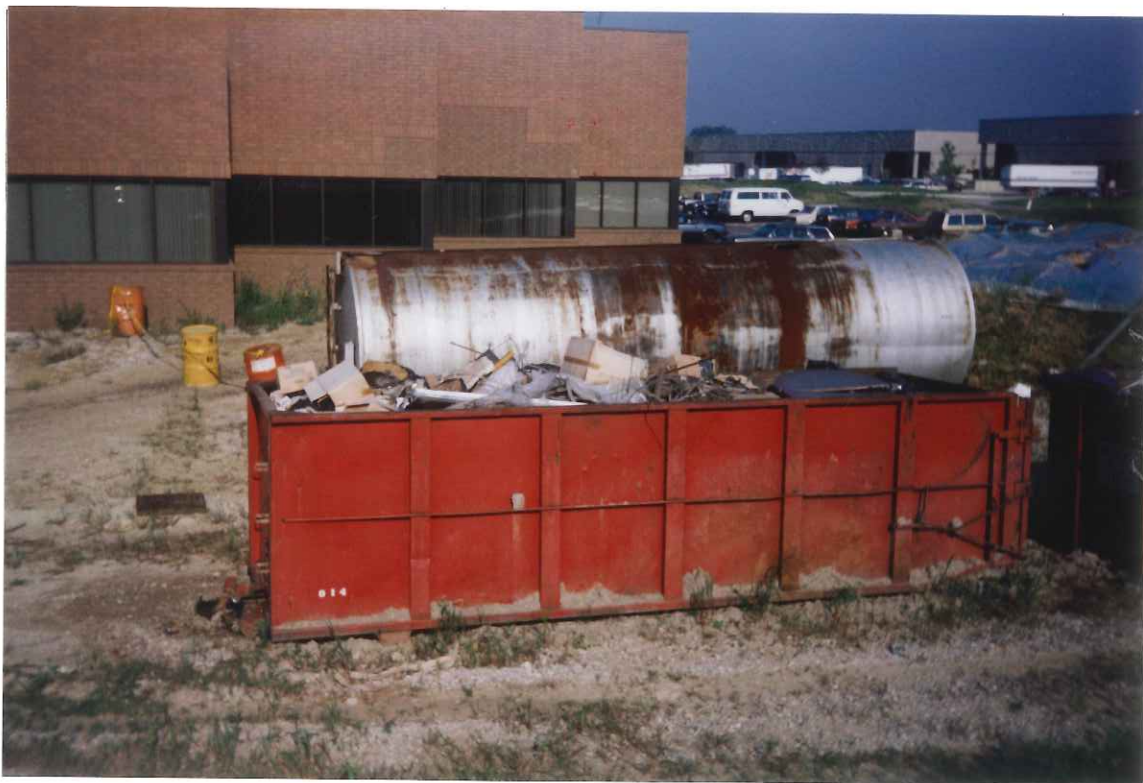
PHOTOGRAPH 6: Trash-filled roll-off
(holding tank in background).
Date: August 16, 1990

- G. VSI Observations: Only two of the roll-offs were completely covered with tarps. One was uncovered and filled with trash. One roll-off in particular looked very worn and rusty. Aggregate was scattered around the base and between the roll-offs.
- H. Sample Results: No additional sample results were provided by facility personnel.

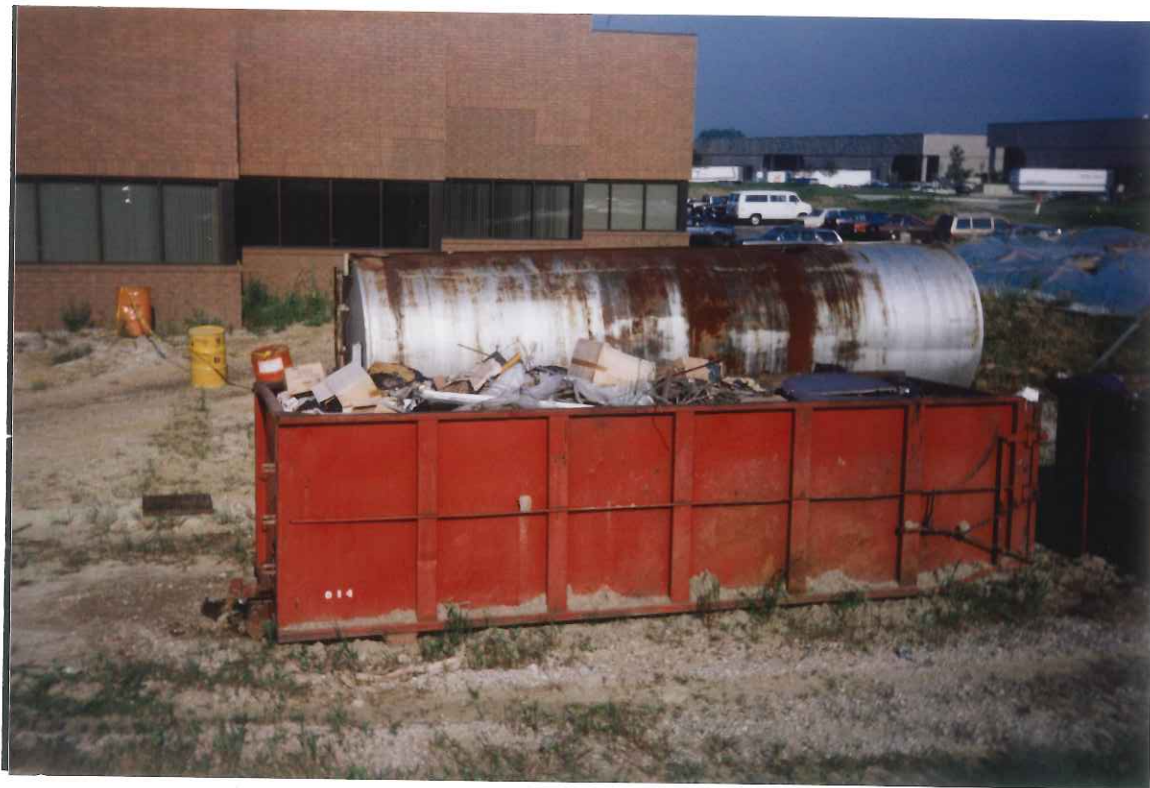
- D. Release Controls: The tank is not capped. There is no secondary containment.
- E. Release History: None.
- F. VSI Observations: The tank appears to be in good condition. There is no evidence of any releases.
- G. Sample Results: Sample results for this unit were not available from facility personnel.

PHOTOGRAPH 7: Holding tank (background).
Date: August 16, 1990
